RAILWAY INVESTIGATION REPORT

R02W0063

CROSSING ACCIDENT AND DERAILMENT

CANADIAN NATIONAL
FREIGHT TRAIN NO. E20251-30
MILE 88.83, RIVERS SUBDIVISION
NEAR FIRDALE, MANITOBA
02 MAY 2002

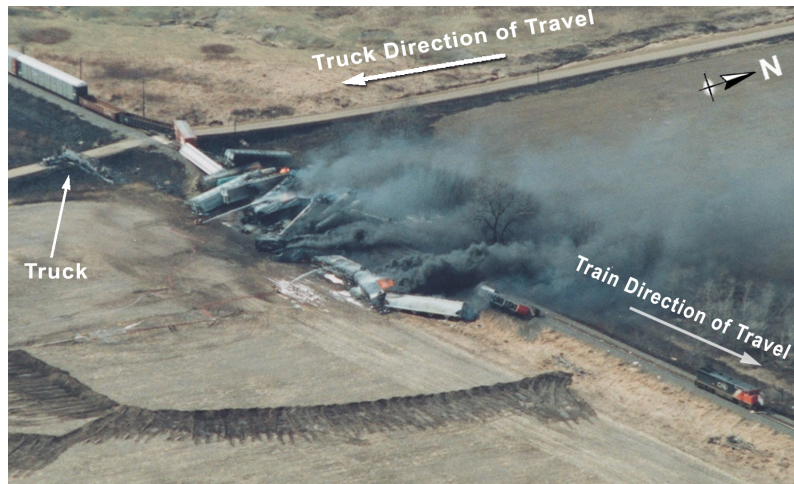
The 2 locomotives and the following 21 cars had derailed, predominantly to the south side of the track. The derailed equipment included 12 covered hopper cars containing plastic pellets, five tank cars carrying dangerous goods (DG) and a tank car carrying ethylene glycol. The DG products included aromatic concentrate (UN 1993), with benzene and dicyclopentadiene being the primary constituents, and alpha olefin C6, with hexene (UN 2370) being the primary constituent. During the derailment, four of the DG tank cars sustained multiple punctures, releasing and igniting the hazardous materials.

As a result of the derailment, a large fire ignited and burned for 2.5 days. No significant physical injuries were reported as a result of the accident or the ensuing emergency response.

Photo 1. Aerial photo of collision and derailment site looking northwest

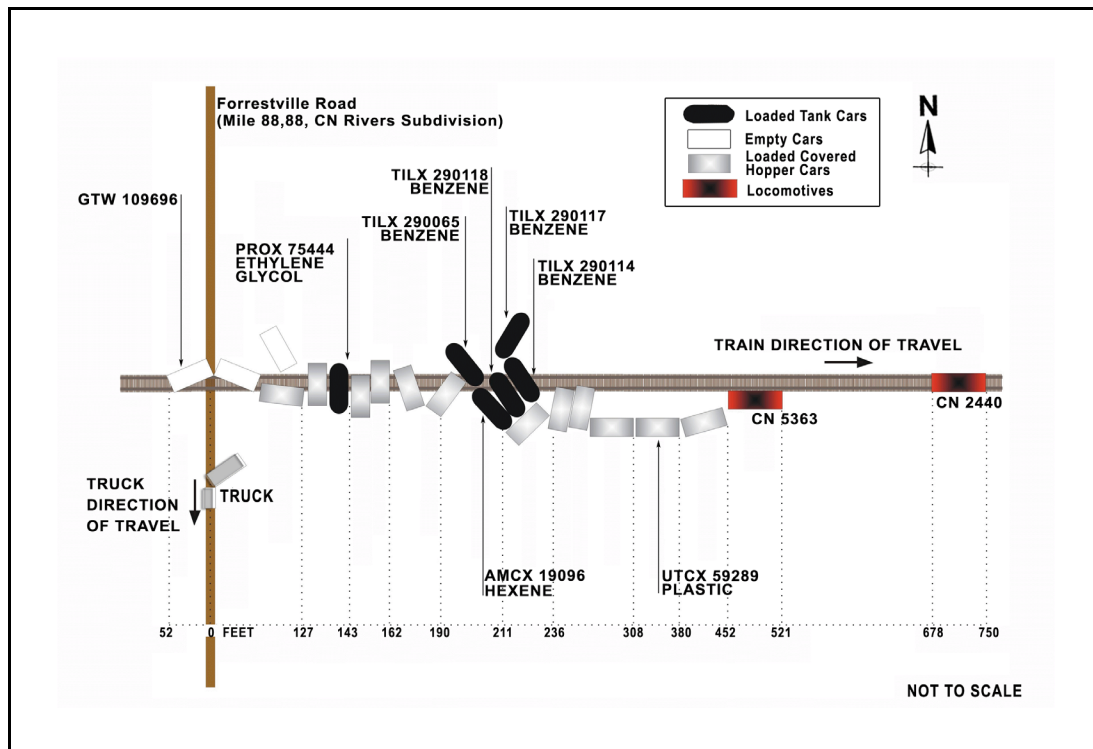
Figure 2. Accident site sketch

The first 17 cars from the head end were destroyed, having sustained varying degrees of fire and derailment damage. The second car, covered hopper UTCX 59289, had been impaled diagonally from the bottom of the B-end to the top of the A-end by a long piece of the south rail. All derailed freight cars and their recovered mechanical components were inspected. No defects were found that were considered causal to the derailment.

Five loaded, low-pressure tank cars carrying DG were involved in the derailment. Four of these tank cars contained aromatic concentrate, with a primary constituent of benzene (UN 1993). One other car contained hexene (UN 2370). These five DG cars were built under tank car construction specification DOT 111A100W1 in 2000. One tank car, the seventh car in the consist, derailed to the north side of the track and remained intact. The tank shell and underframe

displayed various dents, scrapes and gouges, as well as fire damage from flame impingement. The other four tank cars lost most of their product after sustaining multiple punctures to the tank shells. These cars also sustained significant fire damage.

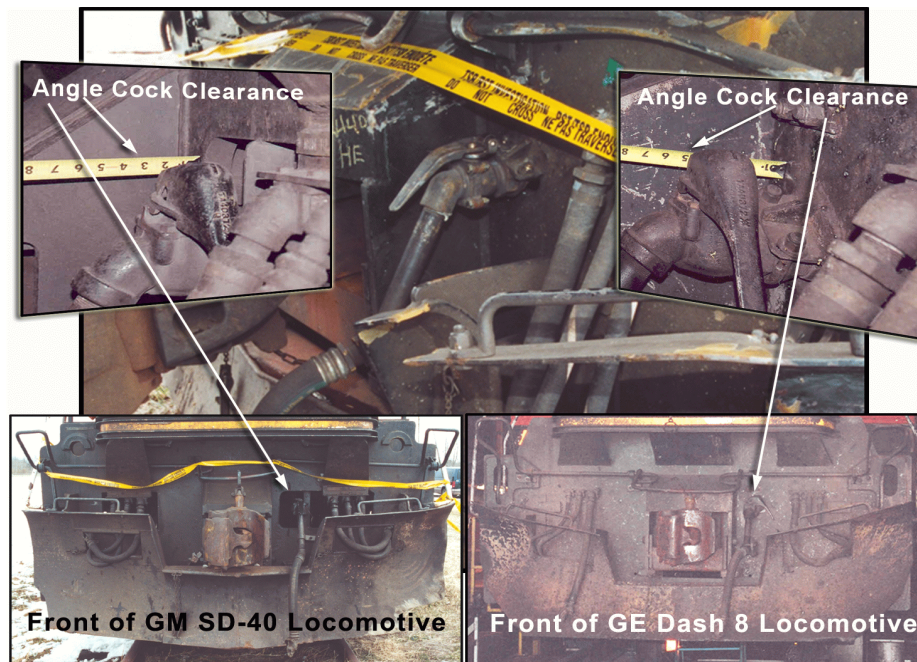
The positioning of the front angle cock and the size and configuration of various components (e.g. locomotive pilots/snow plows) on the front of locomotives can affect the survivability of the front angle cock during a head-end collision. Locomotive snow plow arrangements and the location of the front angle cock vary slightly from one type of locomotive series to another. On GE Dash 8 locomotive units, the snow plow in the area of the angle cock measures approximately 28 inches high and is located approximately 17 inches beyond the front of the locomotive frame. In contrast, the snow plow on GM SD–40–2 locomotives measures approximately 33 inches and is located approximately 19 inches beyond the front of the locomotive frame. In addition, the front angle cock on a GE Dash 8 locomotive extends approximately three inches further than the angle cock on a GM SD–40–2 locomotive. On the whole, the front angle cock of the GE Dash 8 locomotive is more exposed than on the GM SD–40–2 locomotive. Photo 2 shows the configuration of the angle cock on the two locomotives.

Photo 2. Angle cock configuration on locomotive

Due to its location, the front angle cock on locomotives is partially exposed and susceptible to failure upon impact. GE offers alternate locations for the angle cock at the time of locomotive manufacture; however, the locations of the valve and brake pipe hose are typically specified by the purchasing railway, based on the railway's needs. Although the locomotive snow plow was not designed to protect the front angle cock, these attachments do provide a measure of protection. In the event of a head-end collision with a vehicle at a crossing, insufficient protection and/or the location of the angle cock on the lead locomotive increases the risk of an angle cock valve failure. Such valve failures have been known to initiate a UDE from the head end of the train, and the resulting in-train buff forces can potentially cause a rail rollover, jackknife, wheel climb and/or wheel-lift derailment.

1. In the event of a head-end collision with a vehicle at a crossing, insufficient protection and/or the location of the angle cock on the lead locomotive increases the risk of an angle cock valve failure. Such valve failures have been known to initiate an undesired emergency brake application from the head end of the train, and the resulting in-train buff forces can potentially cause a rail rollover, wheel climb, and/or wheel-lift derailment.
2. The five buffer cars required by the *Transportation of Dangerous Goods Regulations* (TDG regulations) in place at the time of the occurrence provided an adequate measure of safety for the train crew. The removal of four buffer cars in the new TDG (Clear Language) regulations (2002) may increase the risk to train crews in the event of a head-end collision resulting in derailment.
